Coatings for Fresh Water Applications:

Ceramic Polymer: Refurbishment of swimming pool filter achieves a reduction of fresh water consumption of nearly 50%

Project: Internal refurbishment of a swimming pool filter tank

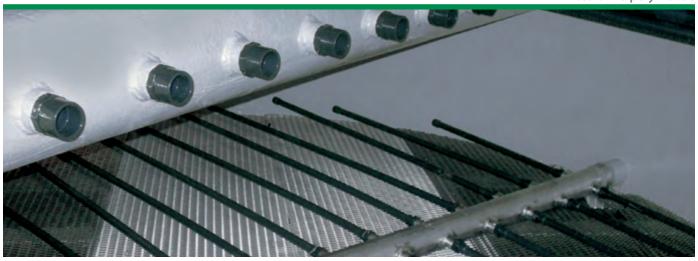
The old, corroded filter significantly caused an immensely high consumption of energy and water.

The filtration performance was affected by agglomerated filter material, but also rust particles polluted the water. A big part of the filtered water had to be back-flushed and treated as waste water.

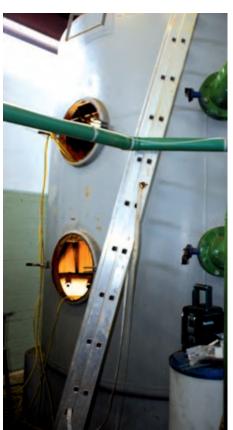
The internal walls and structures of the tank were accurately blasted to remove the deep corrosion and to roughen the steel for coating application. Existing chlorides – determined through the Bresle method – were removed by high-pressure cleaning. Afterwards, the coating was applied by airless spraying and conventional hand tools. In view of the constricted room, that reflects the capability of the company Norbert Reinken.

For the completion Norbert Reinken Company installed new stainless steel tubes and specific basements of expanded stainless steel. The filter material, quartz sand and gravel, were filled in.
