Coatings for Concrete Protection:

Refurbishment of a buffer tank in a sewage plant with Ceramic Polymer concrete protection systems

Project: Refurbishment of buffer tank, sewage plant Radeberg

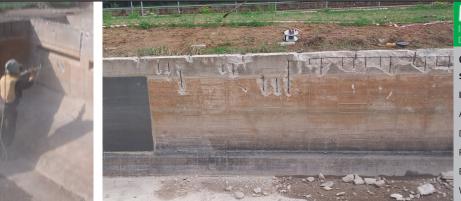
Grit blasted area, loose concrete was removed

First of all, the whole area was grit blasted to clean the substrate. The buffer tank was heavy damaged. By the grit blasting loose and crumbling concrete parts were removed, partially to the steel reinforcement.

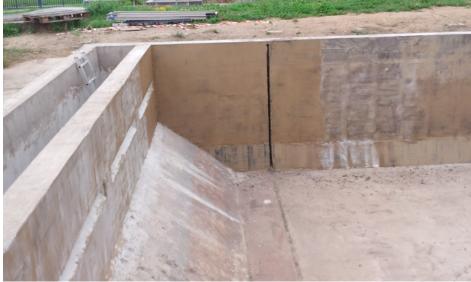
Rebuilt top edge, application of the primer

The walls and the top edge were rebuilt with a high-quality repair grout. Afterwards the area was primed and saturated with our base coat CP-SYNTHOFLOOR BETA 8016. For cavities and unevenness the primer could be mixed with quartz sand for the utilization as a mortar. After the curing the walls were grinded to prepare the concrete for the application of the protective coating.
