Coatings for Biogas Applications:

Restoration of ensilage tank with Proguard CN-1M – effective protection against chemical influences and abrasion

Project: Refurbishment of a concrete tank for biogas ensilage

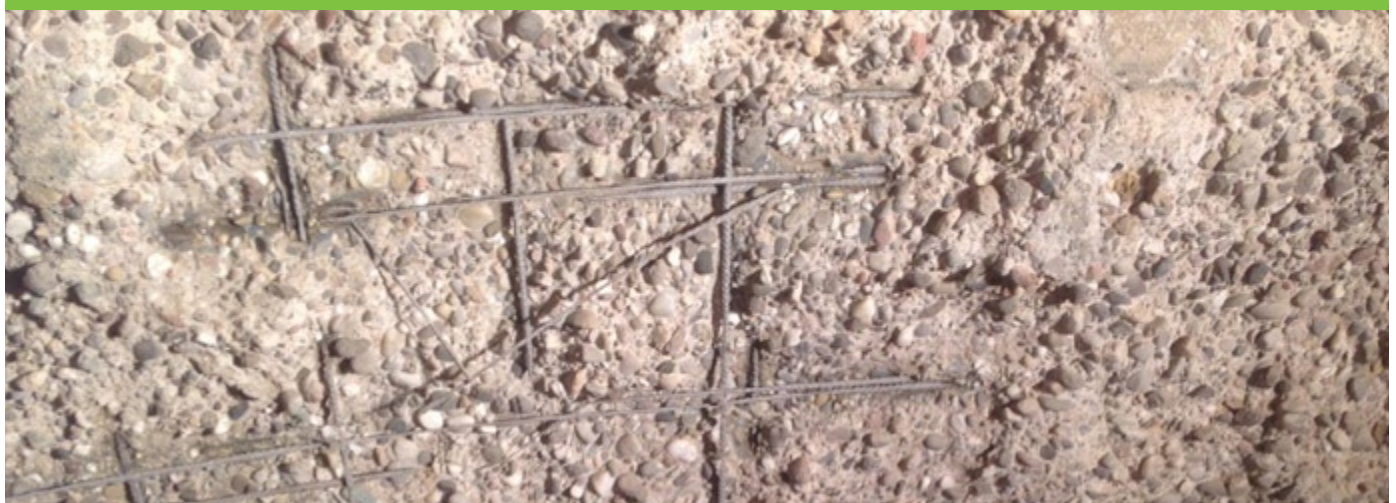
Extreme concrete erosions, induced by biogenic sulfuric acid attack (BSA)

The ensilage tank showed advanced concrete erosions down to the steel reinforcement, induced by biogenic sulfuric acid attack (BSA). Thus, the steel was exposed to high corrosion risk; immediate action was required.

Firstly, the surface was grit blasted to remove loose concrete. Then the tank could be restored with conventional concrete grout.

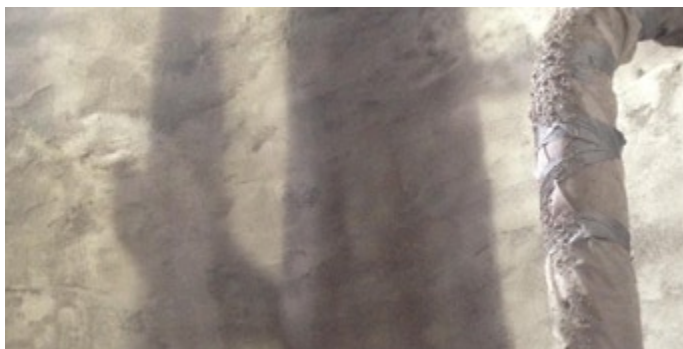
Restored concrete surface

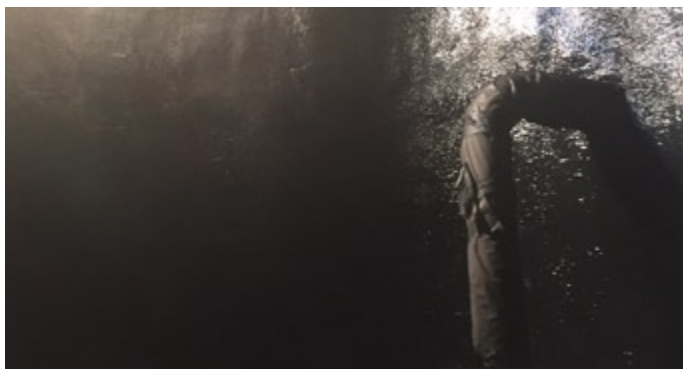
Coated surface

The application of the high-grade chemically resistant coating PROGUARD CN-1M was conducted by airless spraying in a single layer with a thickness of 600 µm. One application procedure is enough to accomplish a reliable protection against aggressive chemical attacks and abrasion damages.

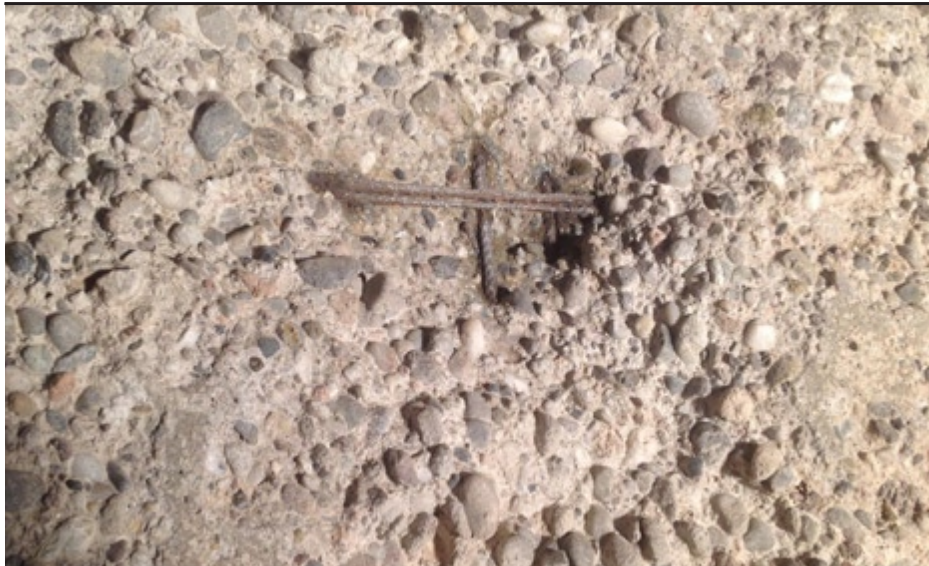
It is a fact; uncoated concrete does not suffice for long-term operation against chemical attack! Through the microbiological decomposition process and the acidic environmental conditions ensilage, biogas and biomass cause an extreme chemical load for the concrete substrate. A high performance coating is required to protect against serious concrete damage.

"Washed-out-concrete-effect" - caused by aggressive acids in the ensilage

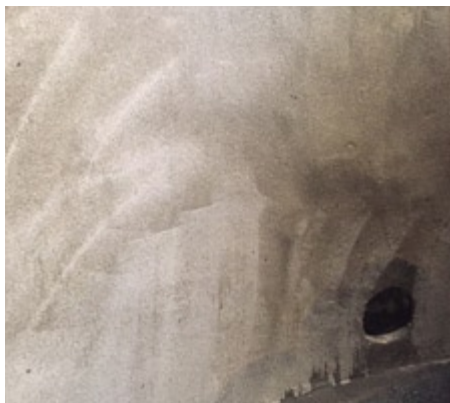
Primed wall area, sprinkled with quartz sand

Afterwards the walls were undercoated with our concrete-primer CP-SYNTHOFLOOR BETA 8016 and lightly sprinkled with quartz sand to achieve an anchorage profile for the protective coating.

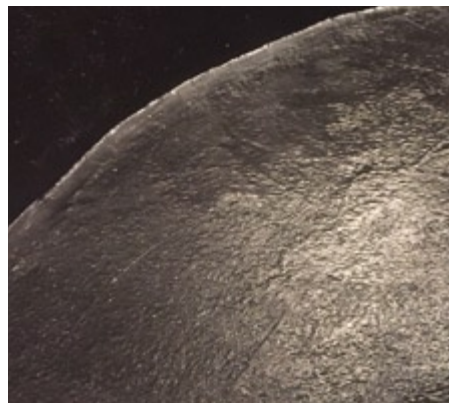
Coated wall and floor

The further process within this extensive restoration was the floor treatment. The repaired concrete was also primed and sprinkled with quartz sand. In this area our product PROGUARD CN-1M was easily applied with a rubber squeegee.

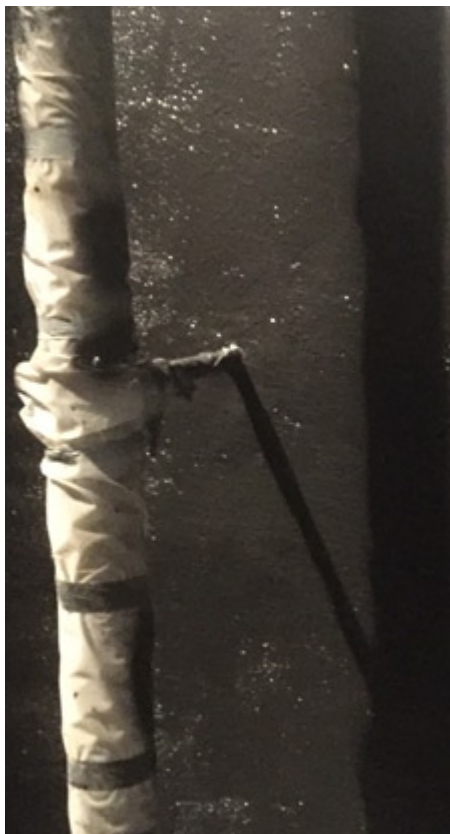
Coated wall area
