Coatings for Concrete Protection:

Refurbishment of a buffer tank in a sewage plant with Ceramic Polymer concrete protection systems

Project: Refurbishment of buffer tank, sewage plant Radeberg

Object: Buffer tank, 70 m long, 8 m wide, 2.5 m deep + additional installations

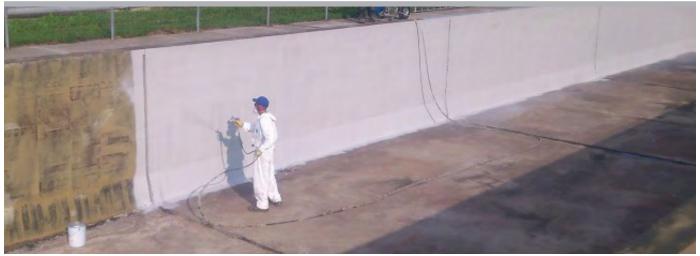
The sewage treatment plant of the German city Radeberg owns a huge equalization tank with a length of 70 m. Due to extreme concrete damages the basin was refurbished extensively. Our long-time partner "ISDW GmbH" conducted the repair of the concrete substrate with our products.

Because of chemical influences concrete structures in wastewater treatment plants show heavy damages after a few years of operation. The area between low and high water level is particularly affected. Furthermore, the top edge is exposed to high mechanical loads by movement and weight of the scraper bridge. Breaking, cracking and sanding of the concrete occur, also through weather conditions and temperature fluctuation.

First of all, the whole area was grit blasted to clean the substrate. The buffer tank was heavy damaged. By the grit blasting loose and crumbling concrete parts were removed, partially to the steel reinforcement.

The walls and the top edge were rebuilt with a high-quality repair grout. Afterwards the area was primed and saturated with our base coat CP-SYNTHOFLOOR BETA 8016. For cavities and unevenness the primer could be mixed with quartz sand for the utilization as a mortar. After the curing the walls were grinded to prepare the concrete for the application of the protective coating.

The high-grade chemical and temperature resistant coating PROGUARD CN 200 was applied by airless spraying method. In combination with the primer this premium coating provides durable protection for concrete areas against aggressive chemical influences and heavy abrasion effects.
